N°	25-27-09
REV	0
DATE	27/11/2023

ACOMPLISHMENT: MANDATORY

1. **PURPOSE:** Detect corrosion and/ or cracks on FWD and AFT wing spar.
2. **BACKGROUND:**

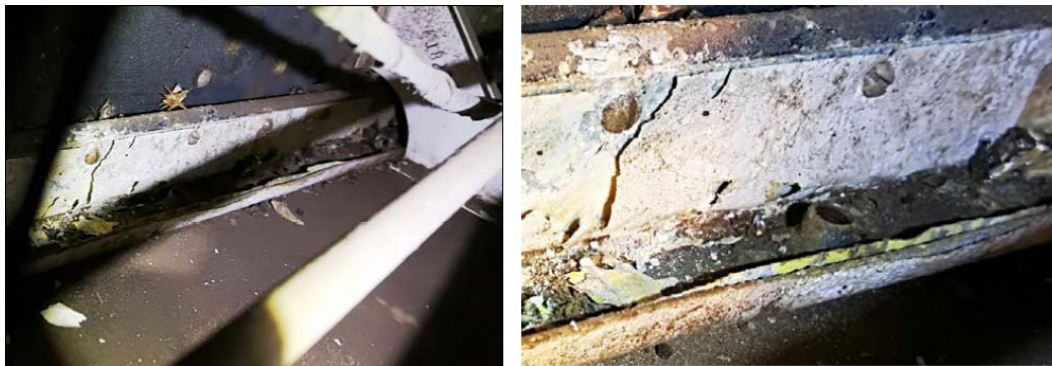
Figure 1

Severe corrosión has been detected on PA-25, PA-25-235 and 260 airplane's FWD and AFT spars in routine inspections.

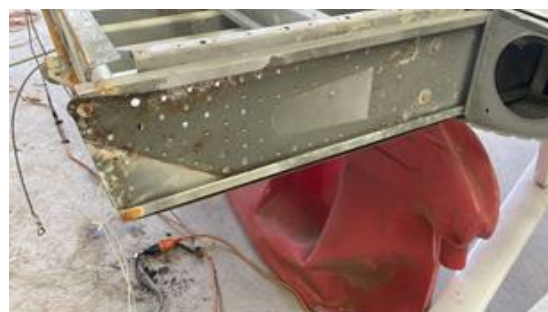
Figure 2

Also corrosión has been detected behind reinforcements P/N 60373-01/-02. as can be seen in figure 2.

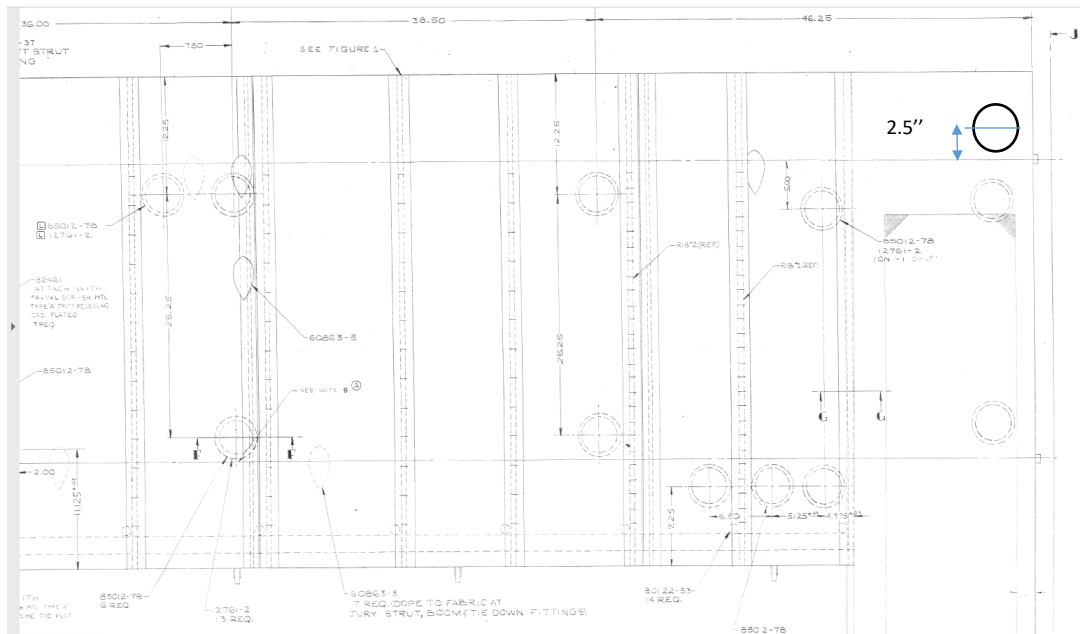
Picture 5

New
inspection
Hole ø 3.5"

- a. Take out inspection cover from both semi wings intrados. See inspection covers distribution drawing. If it doesn't have installed some inspection covers indicated in Picture 3 y 4, install it according subject 6 "Inspection holes installation instruction (Picture 6)". Also install an inspection hole in front of fwd spar attachment, according to inspection holes distribution drawing (Picture 5)

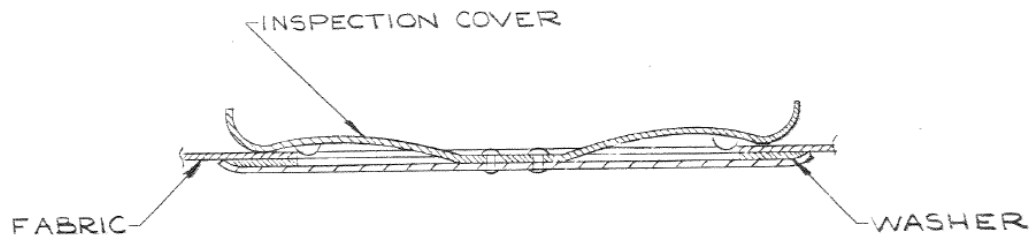
Picture 7

SECTION **F-F**
INSPECTION HOLE DETAIL
FULL SIZE

f.5. Install cover plates according picture 7
